Close Out Documents

AP-72 – 4550 Clayton St.

Asbestos Abatement and Structural Demolition

Structure Survey Assessment Report AP-72

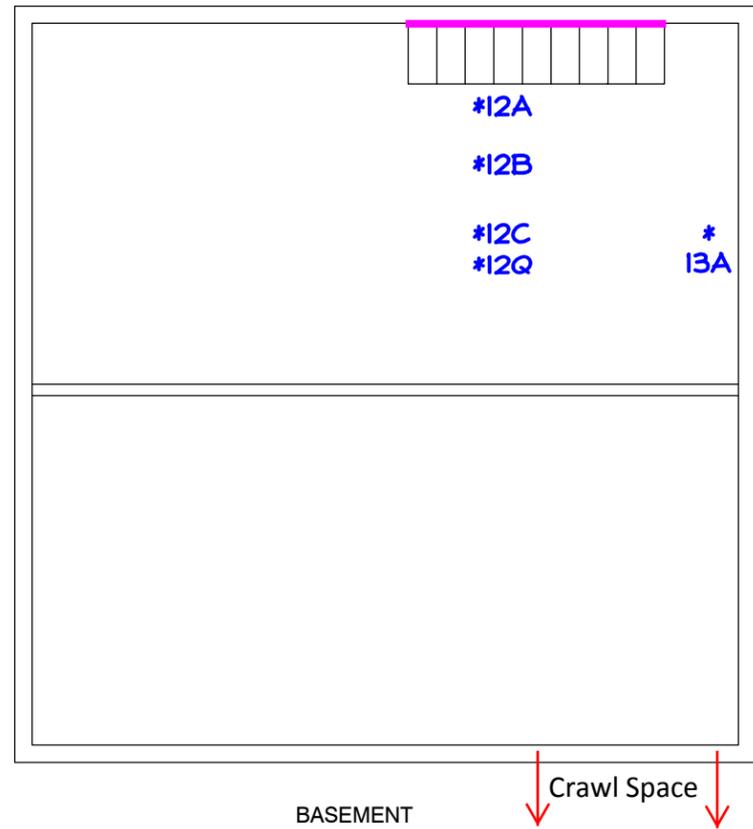
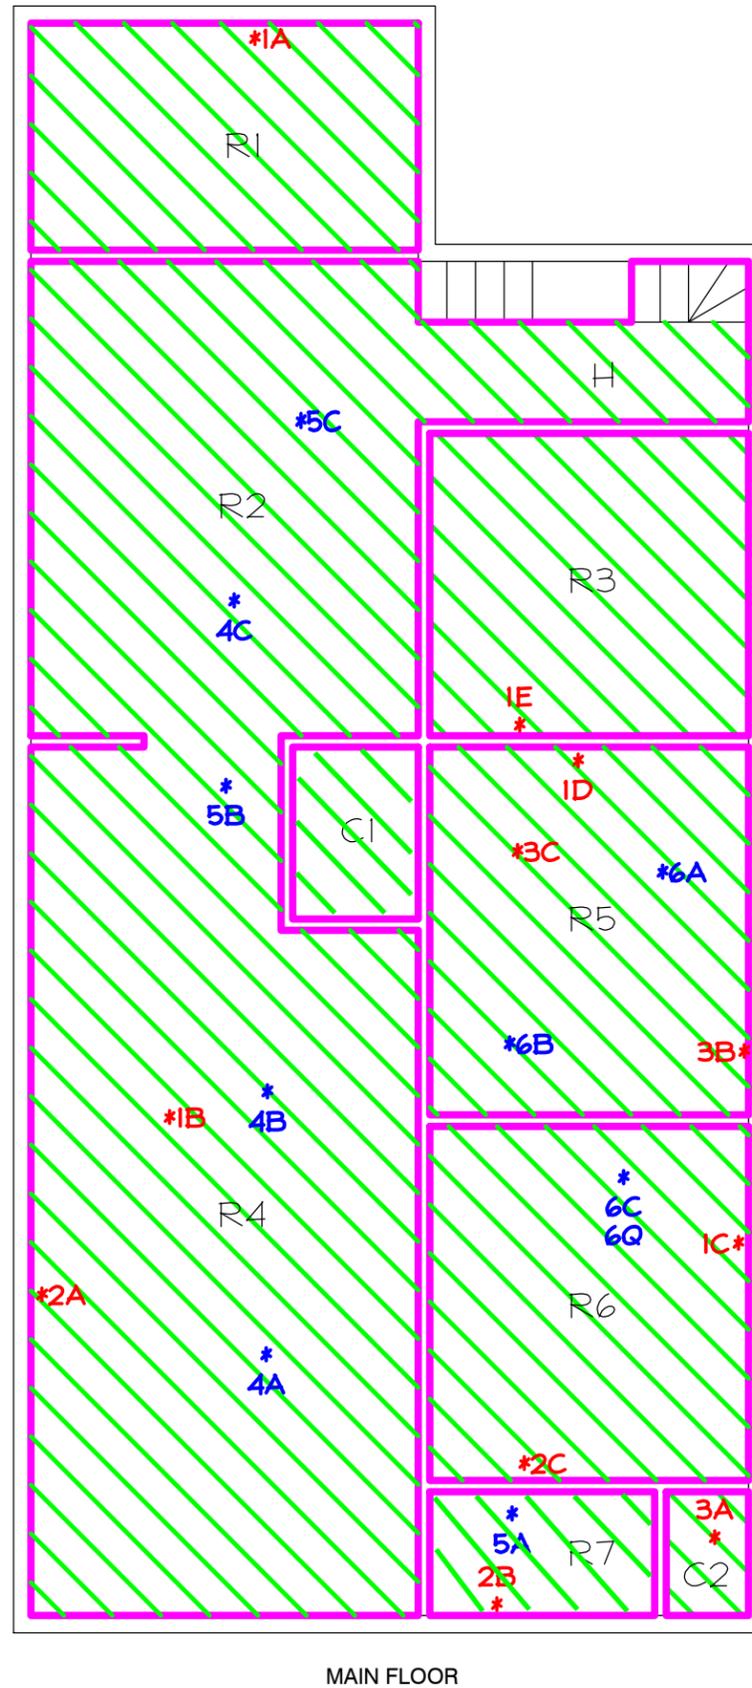
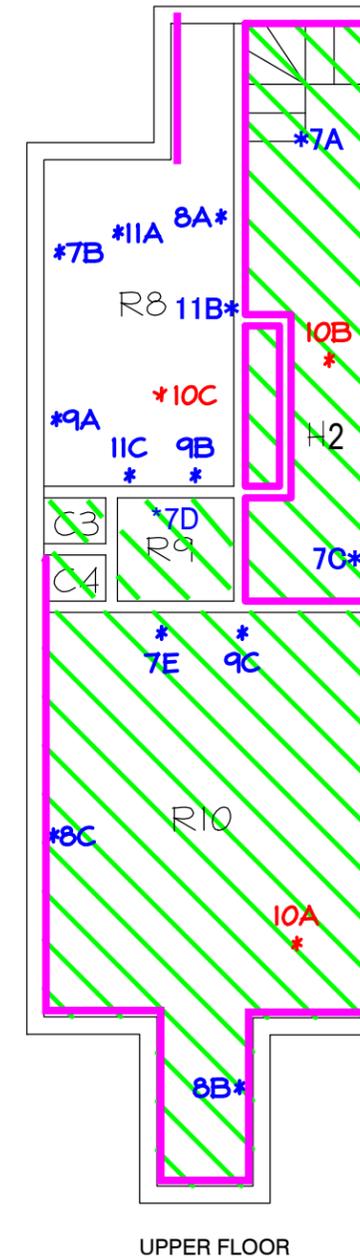
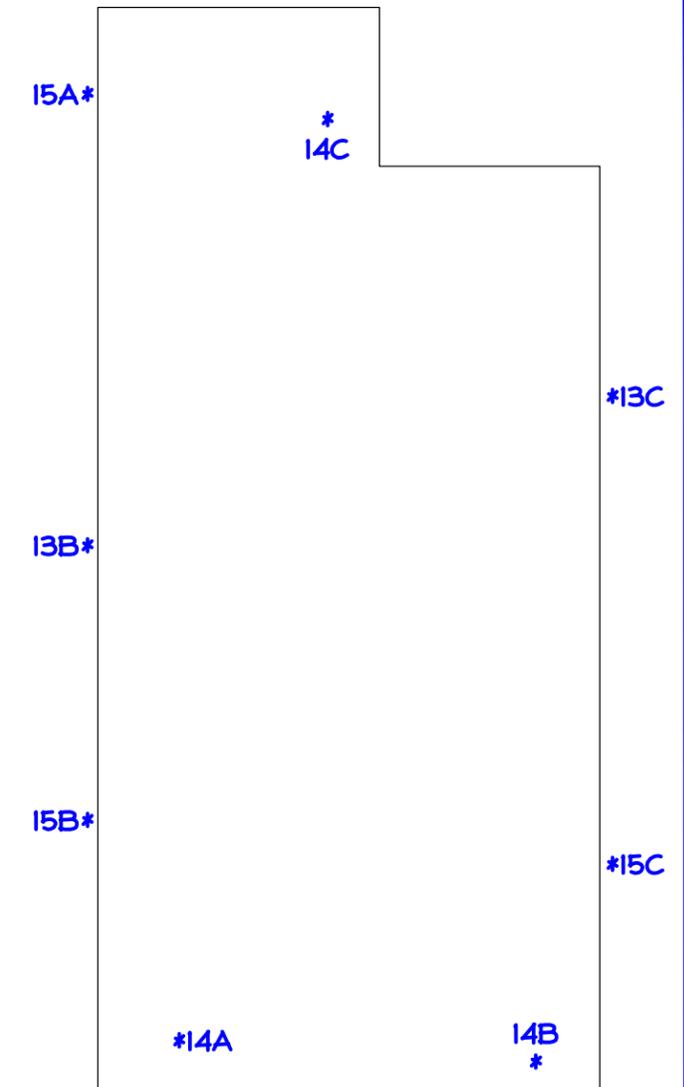
FIGURE 2 - Asbestos Bulk Sample Locations
CENTRAL 70 - Structure Survey Assessment Map
AP-72
 4550 Clayton Street, Denver, CO
 June 7, 2018
 APEC #: 18-3066

- R1 = Room Numbers
- 4B = Asbestos Samples (Detect)
- 4B = Asbestos Samples (Non-Detect)
- = Positive Asbestos at Ceiling
- = Positive Asbestos at Walls

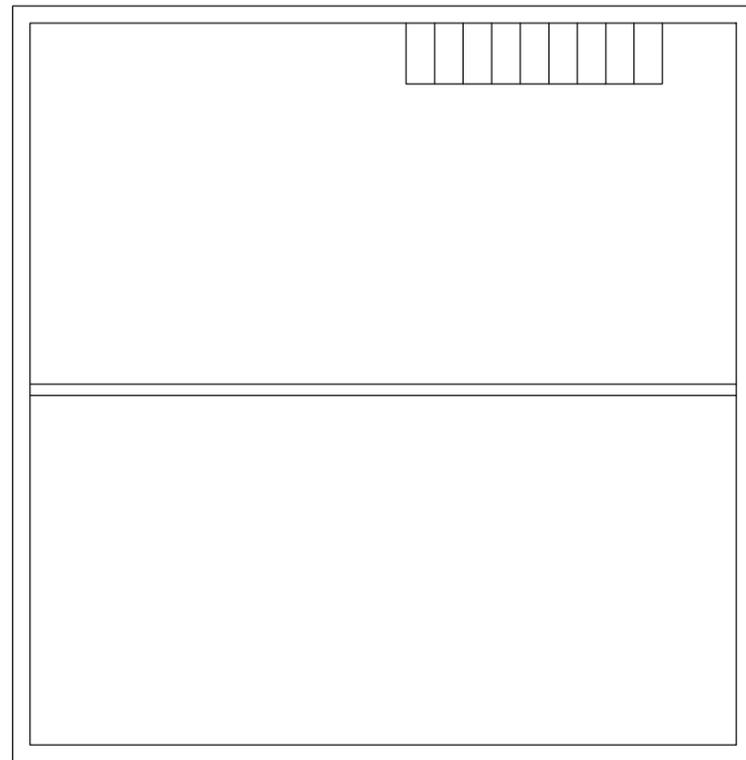
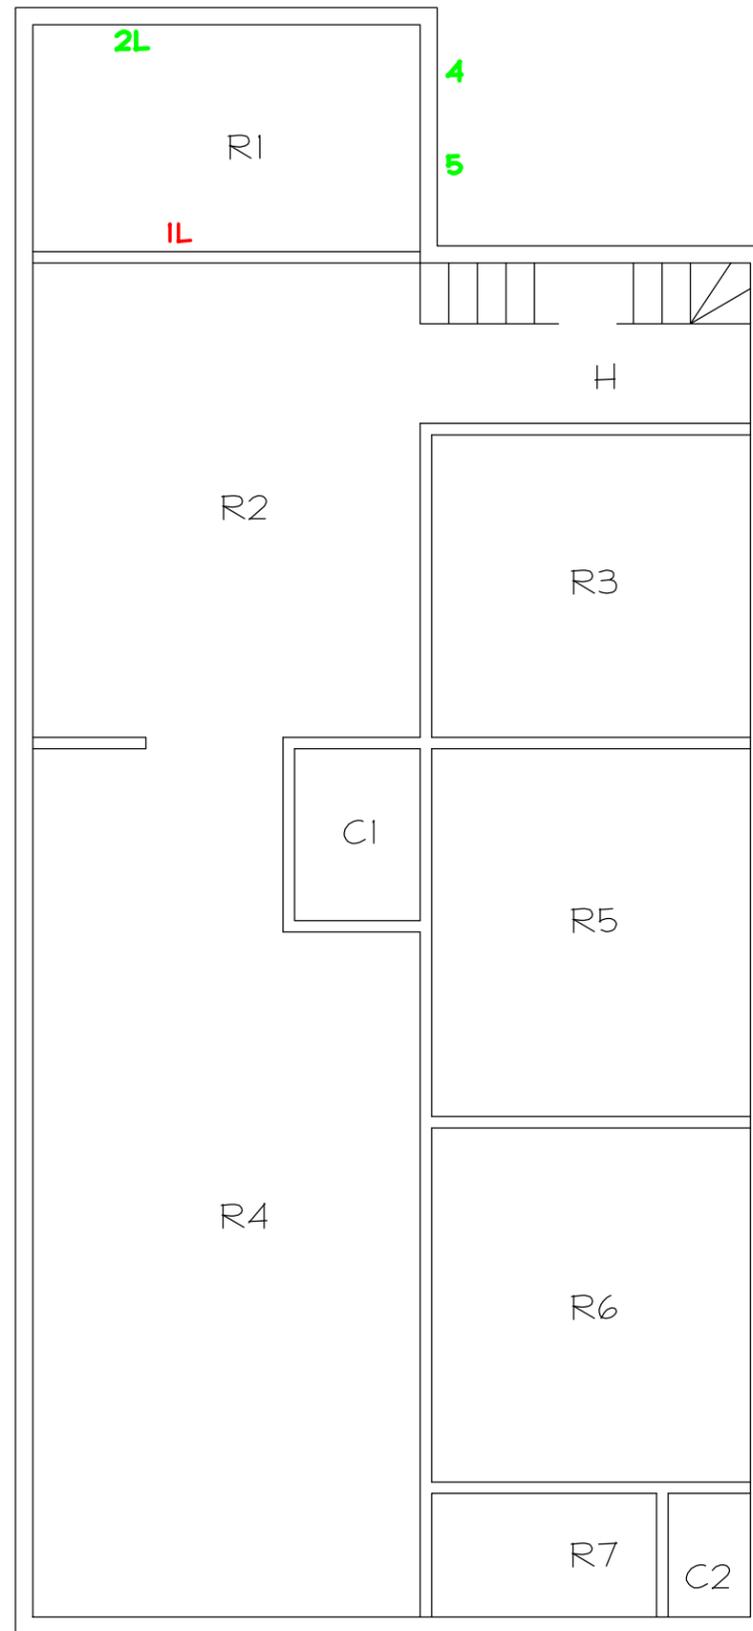
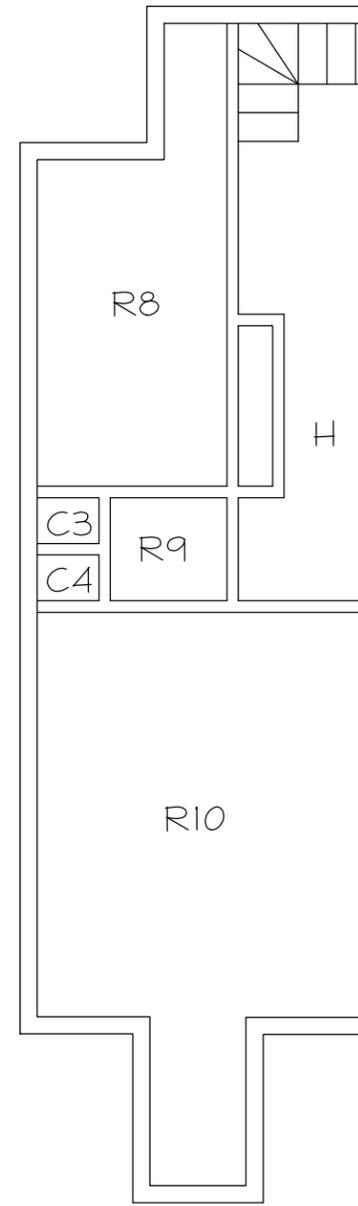
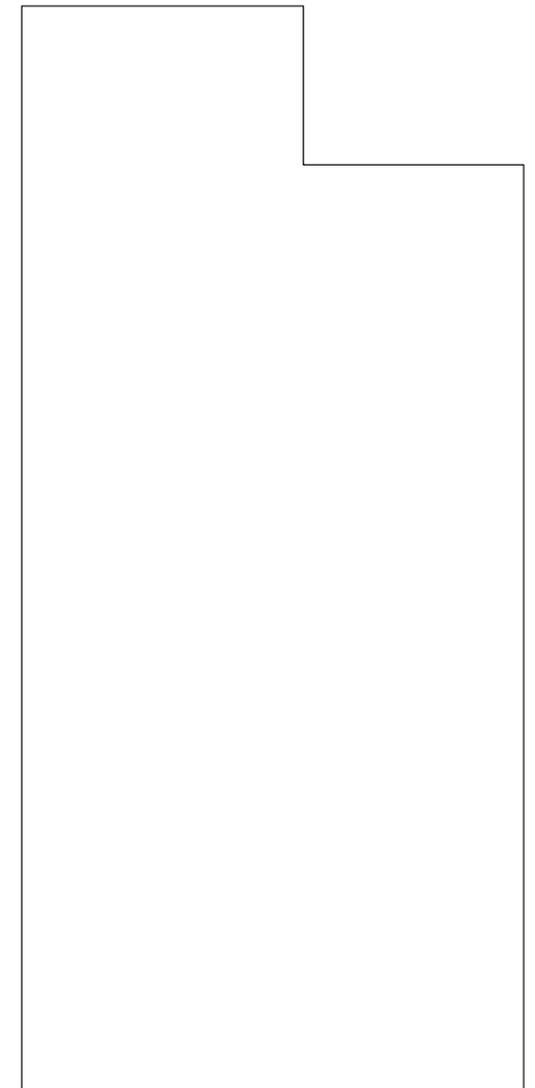
FIGURE 3 - Lead Based Paint Sample Location
CENTRAL 70 - Structure Survey Assessment Map
AP-72
 4550 Clayton Street, Denver, CO
 June 7, 2018
 APEC #: 18-3066

One lead sample (4550C-L-1L) was found to be greater than 0.06% by weight and less than 0.5% by weight and is considered LCP (Table 4). The remaining 5 samples were less than the LCP and LBP thresholds, and are considered non-lead containing paint (NLC). The laboratory analytical report is included in Appendix D.

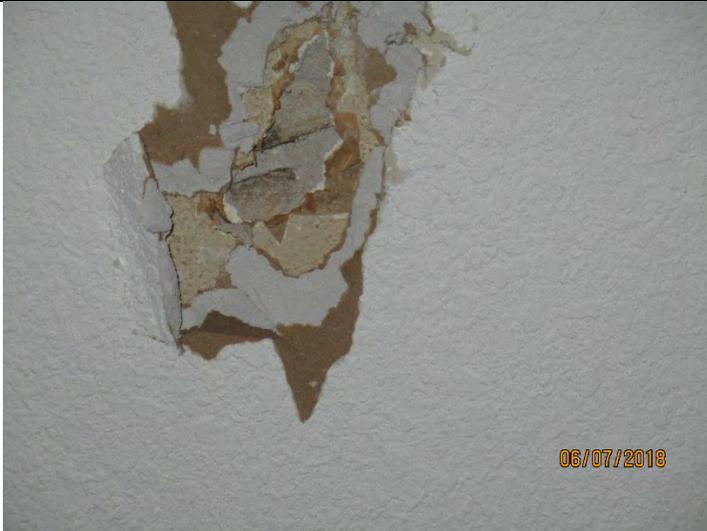
Knockdown Textured Drywall

Samples Represented –
4550CL-R1-TD1A
4550CL-R4-TD1B
4550CL-R6-TD1C
4550CL-R5-TD1D
4550CL-R3-TD1E

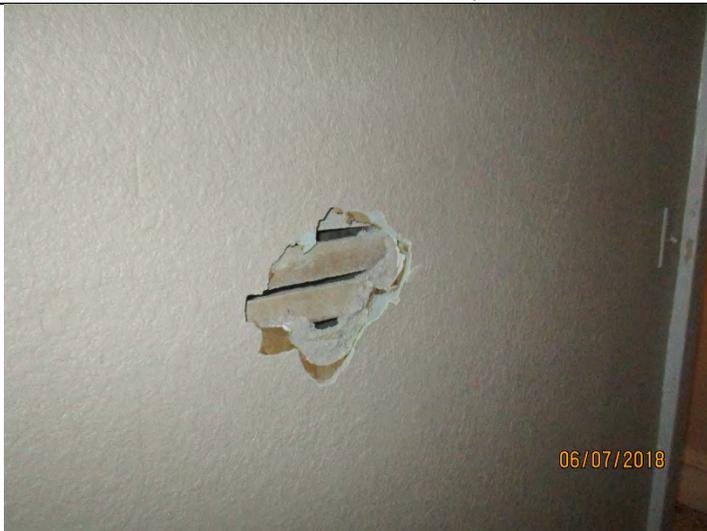
Knockdown Textured Plaster

Samples Represented –
4550CL-R4-PL2A
4550CL-R7-PL2B
4550CL-R6-PL2C

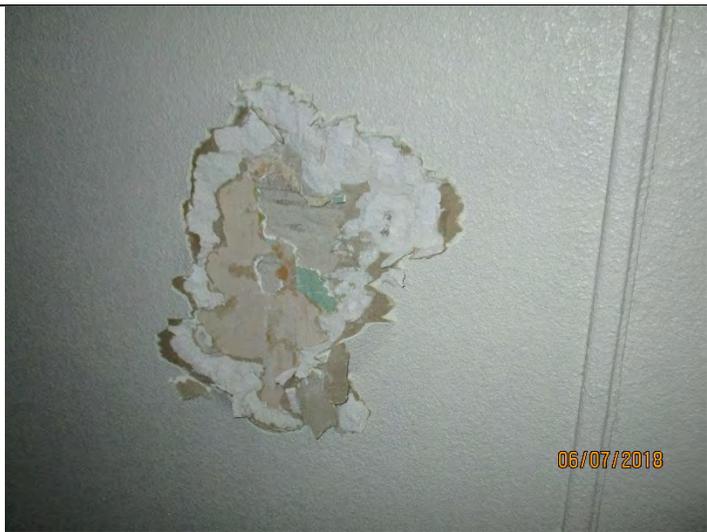
Textured Plaster-second layer

Samples Represented –
4550CL-R4-PL3A
4550CL-R5-PL3B
4550CL-R5-PL3C

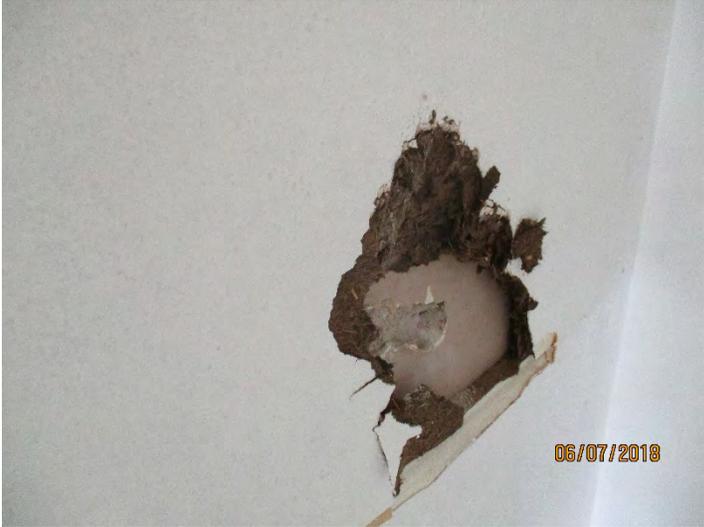
Plaster

Samples Represented –
4550CL-R10-PL10A
4550CL-H2-PL10B
4550CL-R8-PL10C

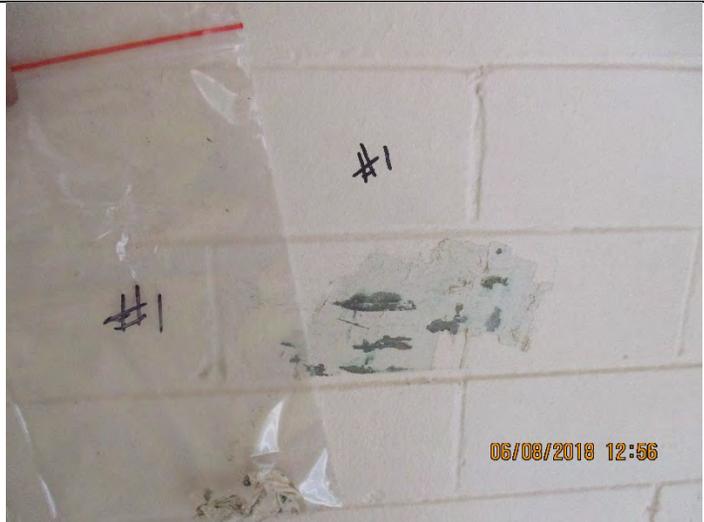
Peach - LCP

Sample Represented –
4550C-L-1L

While the TCLP results indicate that the waste stream is not characteristically hazardous with respect to lead content, LCP and LBP are still present in the building materials. Therefore, the contractor responsible for demolition of this structure is notified with receipt of this report of the presence or potential presence of LCP and/or LBP in the building materials that comprise the building. The contractor should also notify their employees of the presence of LCP or LBP prior to any disturbance and make the US Department of Labor OSHA publication number 3142-12R 2004 available to their workers. (“Lead in Construction”, <http://www.osha.gov/Publications/osha3142.pdf>). The standards address topics such as PELs for workers, exposure assessment, protection of employees during assessment of exposure, employee notification, PPE, medical surveillance, along with other topics related to working with LCP and LBP.

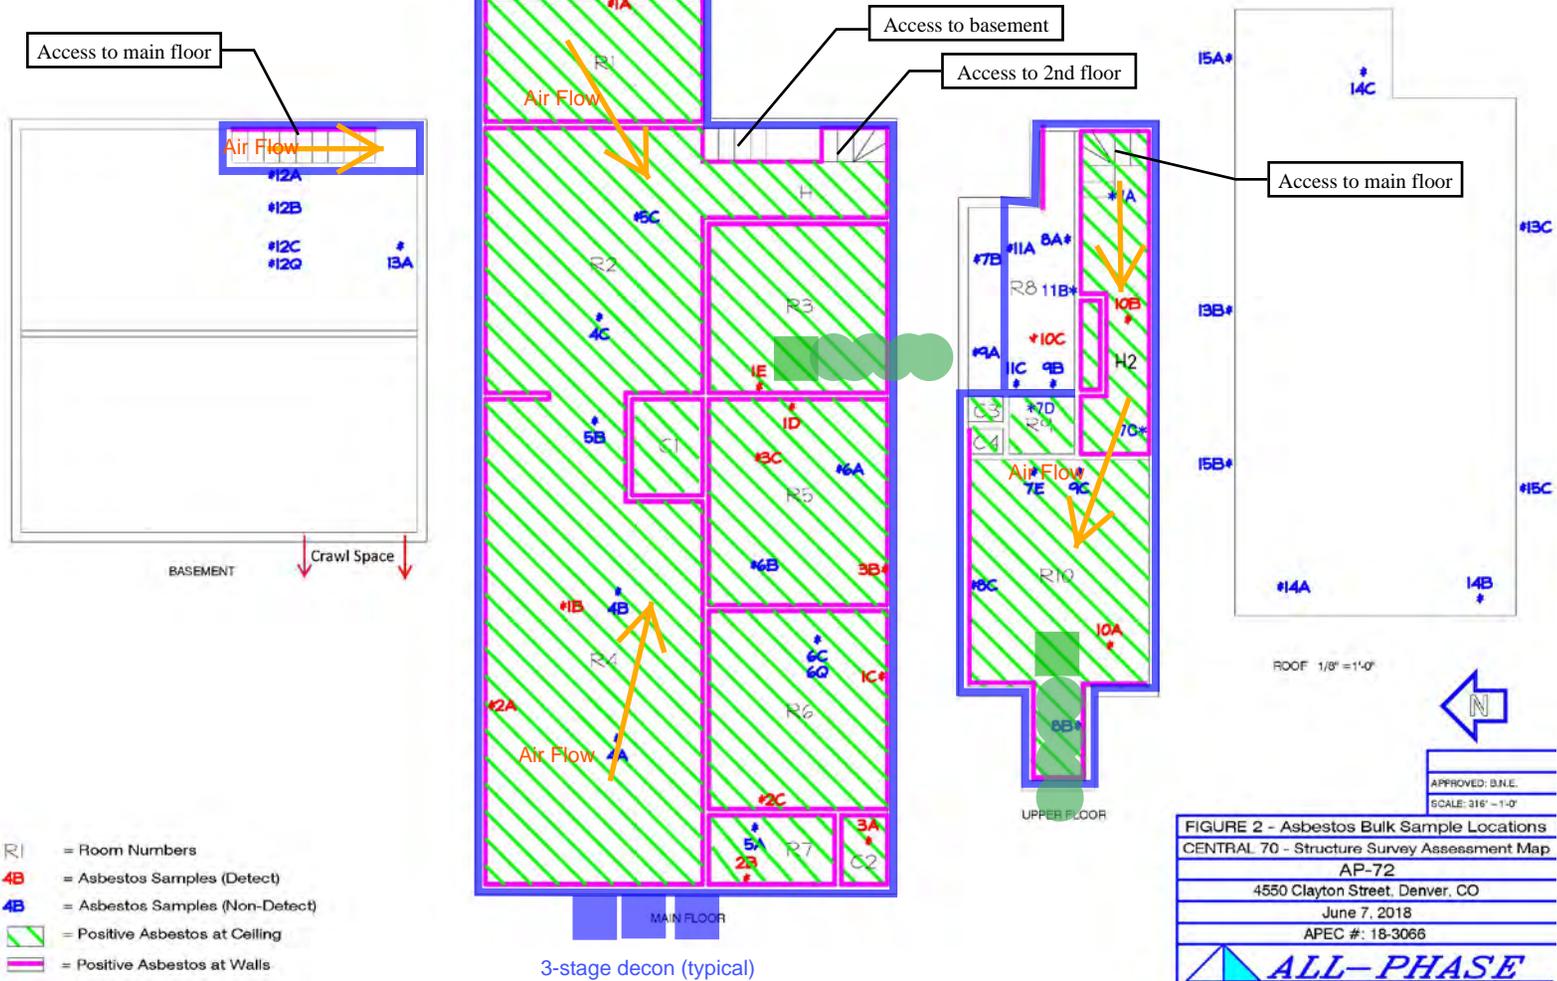
FIGURE 2 - Asbestos Bulk Sample Locations
 CENTRAL 70 - Structure Survey Assessment Map
 AP-72
 4550 Clayton Street, Denver, CO
 June 7, 2018
 APEC #: 18-3066

ABATEMENT IN FULL CONTAINMENT (11/06/18 - 11/20/18)
